## MOJ Proposed lift location details;

Existing site condition;

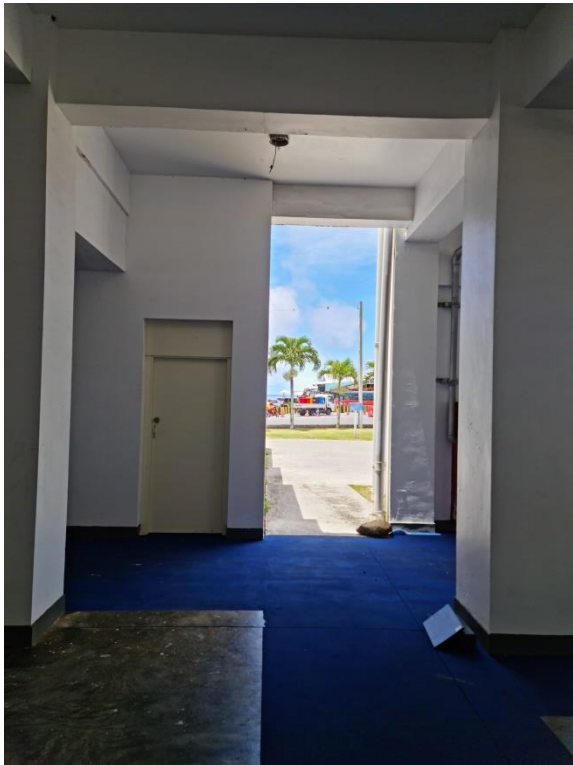
Northern view of the location towards the Avarua harbour,

- Single concrete column in the background, door for a storeroom to the left of the opening and the two concrete columns in the foreground

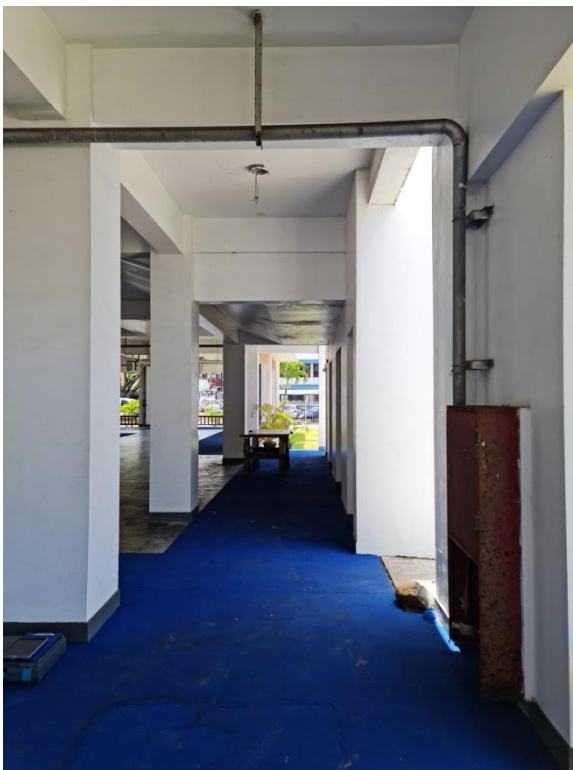
View towards the west,

- Fire hydrant box in the foreground on the wall to the right, with 100mm diameter galvanised water pipeline connected to the fire hydrant, note floor colour of blue only partial while rest of floor smooth concrete finish

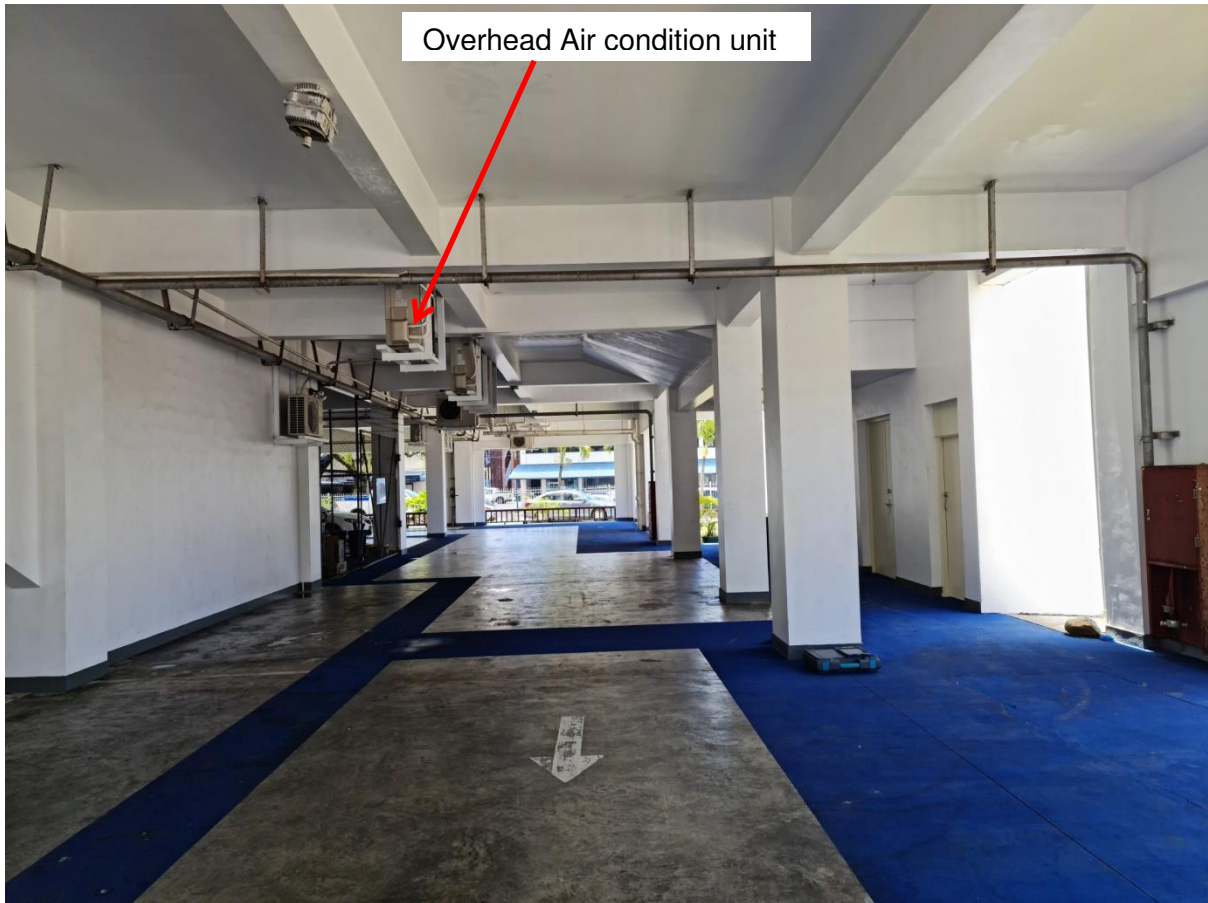
Overhead Air condition unit

The overhead air condition unit will be directly in the entrance way of the lift, and the condensation from the unit is now dripping directly on to the floor which can be hazardous to the users of the lift.

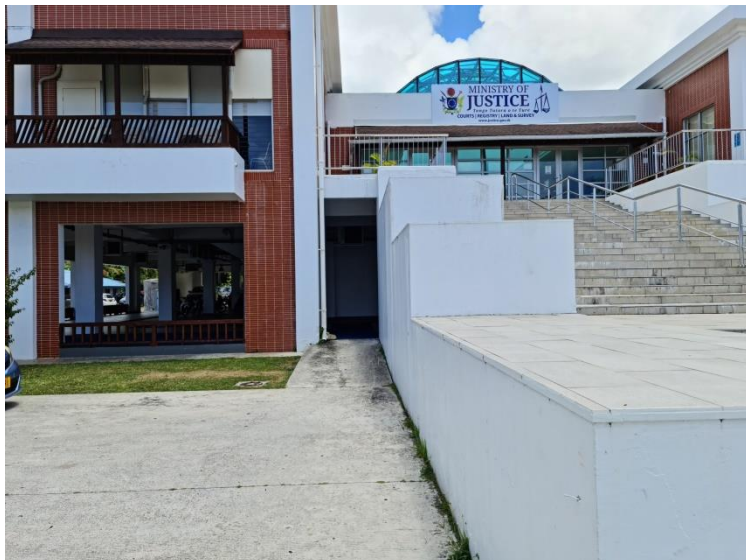
Frontal view of the lift location with the opening to the east of the stairway
